WOOD DESTROYING PESTS AND ORGANISMS INSPECTION REPORT

#: 68242

BUILDING NO. 275	STREET CHIRCO	CITY SANTA CRUZ	ZIP 95065	Date of Inspection 10/06/2011	NUMBER OF PAGES 1 of 7
---------------------	------------------	--------------------	--------------	----------------------------------	---------------------------

This is a one story, wood and stucco, single family residence. It has a composition roof and was occupied and furnished at the time of inspection.

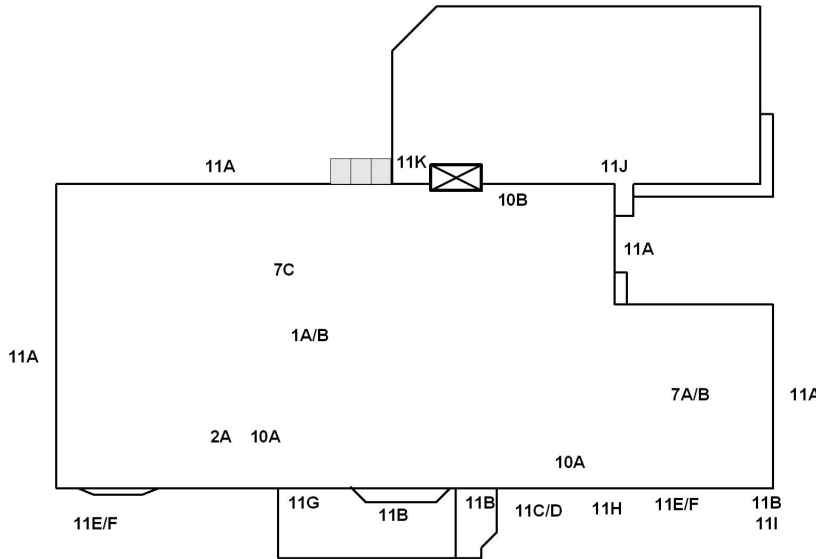
Key: 1 = Substructure 2 = Stall Shower 3 = Foundation 4 = Porches 5 = Vents 6 = Abutments 7 = Attic 8 = Garage 9 = Patio 10 = Interior 11 = Exterior

There is CELLULOSE DEBRIS and paper on the soil noted as 1B on the diagram.

The master bathroom STALL SHOWER is leaking as indicated by 2A on the diagram. No damage was noted below the shower.

The toilets in the hall and 3/4 bathrooms are loose as indicated by 10A on the diagram.

There is FUNGUS/DRY ROT and DRYWOOD TERMITE DAMAGE on the siding and trim at several locations indicated by 11B on diagram.

There is evidence/infestation of DRYWOOD TERMITES on the exterior, bathroom window frame, and the attic as indicated by 11C on the diagram.

There is FUNGUS/DRY ROT DAMAGE on the door jamb indicated by 11G on diagram.
Remove all damage. Set new jamb material.

There is FUNGUS DAMAGE on the Varge rafter as indicated by 11J on diagram.
Remove all damage. Splice-in new material.

There is FUNGUS/DRY ROT DAMAGE on the roof sheathing as indicated by 11K on diagram.
Remove the damage as needed. Set new material and/or pack and fill the damaged area with wood filler and seal as needed.

We recommend removing all CELLULOSE DEBRIS and paper of rake size or larger.

We recommend removing the bottom three rows of tile, the pan, and the curb. If no damage is found above the opened area, install a new waterproof membrane, water test to ensure no leaks. Replace the tile with a similar quality and neutral color. Price on the report is for others to repair.

We recommend contacting a licensed plumber to replace the seal and resecure the toilet.

Remove all damage. Set new material. If additional damage is found during the course of repairs, call to have a supplemental report issued.

Fumigate the structure with a fumigant VIKANE (SULFURYL FLOURIDE.) lethal to DRYWOOD TERMITES. See the occupants fumigation notice for further details. The structure must be vacated for 72 hours (3 days) for the fumigation process. This company is not responsible for delays or schedule changes due to inclement weather or other agencies, nor is it responsible for damage to roof or plants as a result of the fumigation. We recommended removing or trimming back plants 6-8 inches from the structure. Refer to the occupant's fumigation notice/preparation sheet (sent separately) for additional information.
