WOOD DESTROYING PESTS AND ORGANISMS INSPECTION REPORT

#: 68242

BUILDING NO. 275	STREET CHIRCO	CITY SANTA CRUZ	ZIP 95065	Date of Inspection 10/06/2011	NUMBER OF PAGES 1 of 7
---------------------	------------------	--------------------	--------------	----------------------------------	---------------------------

This is a one story, wood and stucco, single family residence. It has a composition roof and was occupied and furnished at the time of inspection.

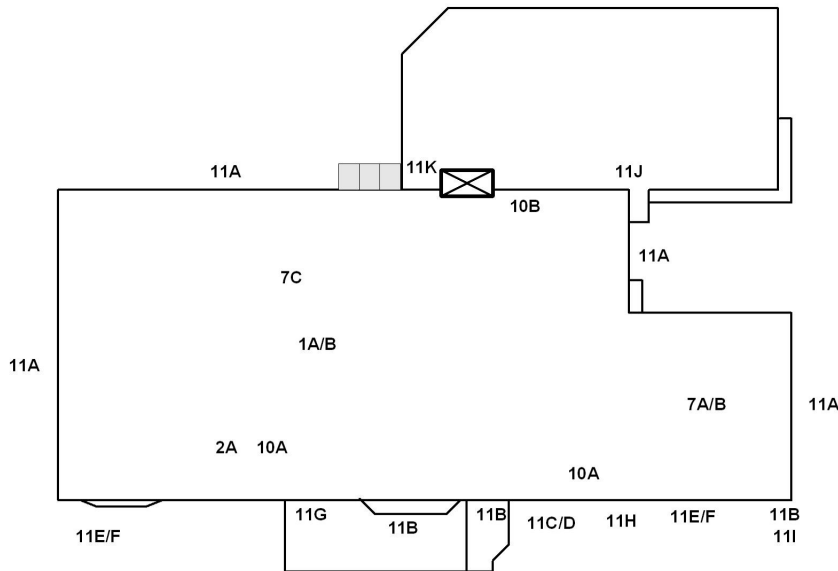
NOTE: If diagram is not displayed here, please see the report.

There is FUNGUS/DRY ROT and DRYWOOD TERMITE DAMAGE on the siding and trim at several locations indicated by 11B on diagram.

There is FUNGUS/DRY ROT DAMAGE on the door jamb indicated by 11G on diagram.
Remove all damage. Set new jamb material.

There is FUNGUS DAMAGE on the Varge rafter as indicated by 11J on diagram.
Remove all damage. Splice-in new material.

There is FUNGUS/DRY ROT DAMAGE on the roof sheathing as indicated by 11K on diagram.
Remove the damage as needed. Set new material and/or pack and fill the damaged area with wood filler and seal as needed.

Remove all damage. Set new material. If additional damage is found during the course of repairs, call to have a supplemental report issued.
